PREPARED FOR:
JOHN DOE (SAMPLE REPORT)

INSPECTION DATE:
Wednesday, May 15, 2019

Your Inspection Report

Report No. 1013, v.2

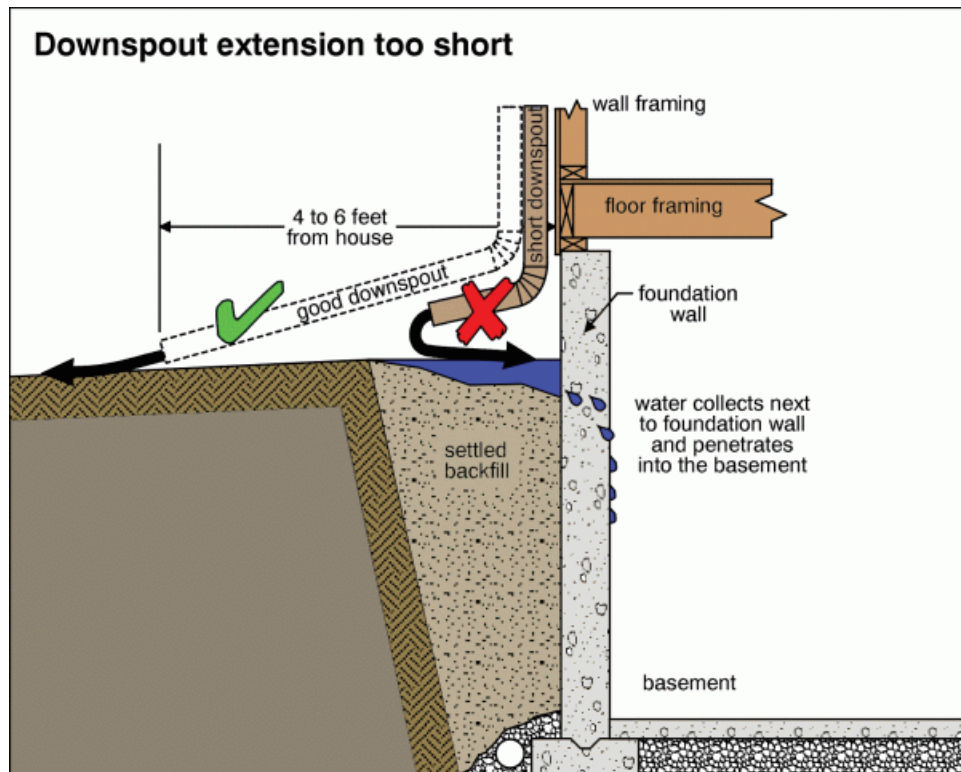
2. Condition: • Downspout discharge too close: To prevent foundation leaks, improve downspouts to direct water at least 5 feet away from the house. Encourage stormwater to flow away from the building at the discharge point. Leaky foundations near downspouts indicate poor drainage. Consider installing downspout extensions where possible.

Task: Improve / Repair

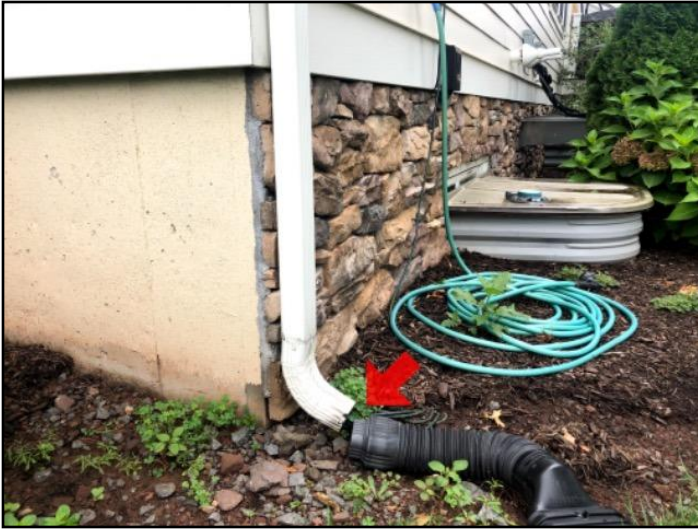
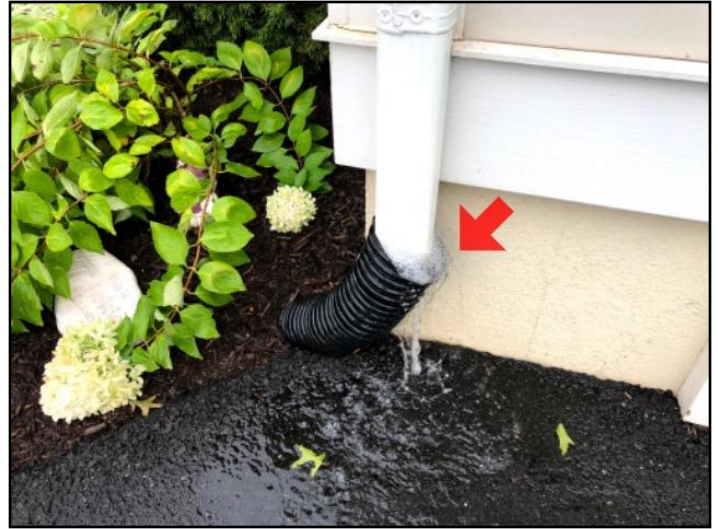
3. Condition: • Downspout connection: I recommend improving the connection between the downspout and the extension. Make sure all downspouts are connected and routed to discharge water away from the home foundation.

Not properly connected. Repair Recommended

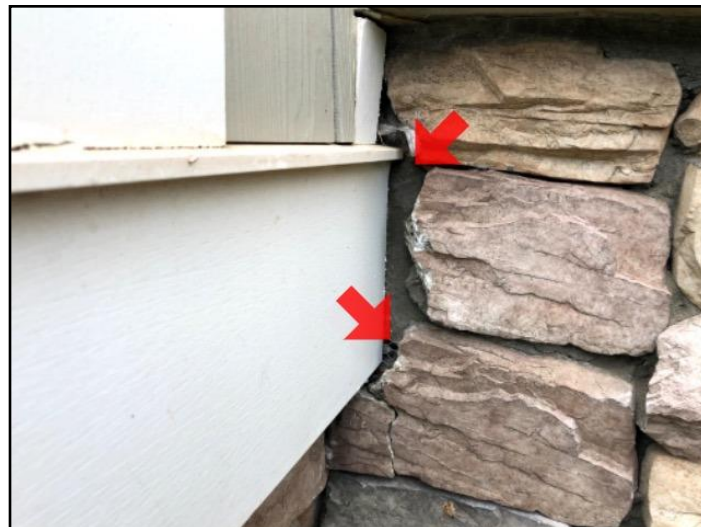
4. Condition: • The gap between the trim and the siding at the Front Right Side Exterior should be sealed.

Task: Repair

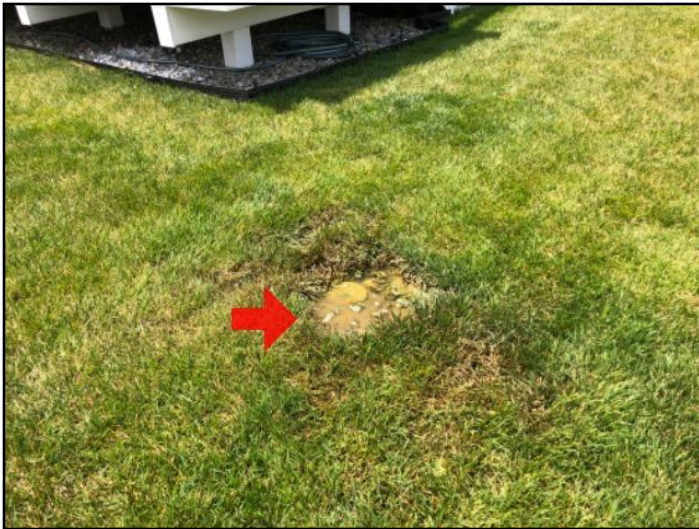
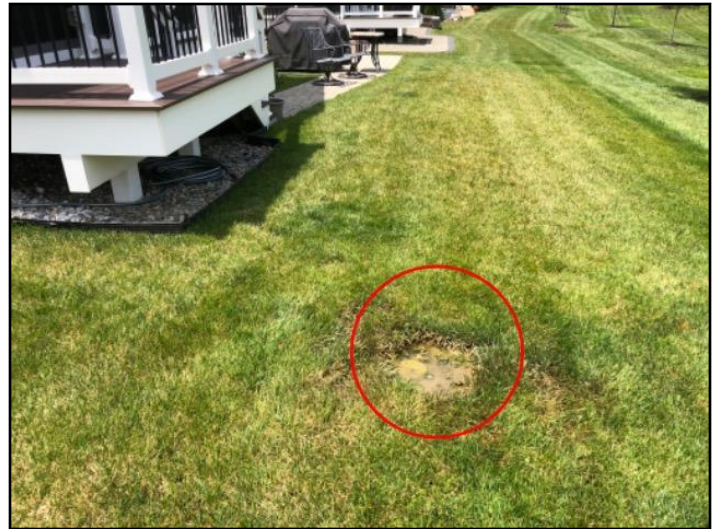
5. Condition: • Evidence of ponding water in the yard. Ideally, water should run off the yard within 48 hours. Improve grading: The grading should be improved to promote the flow of storm water away from the house. This can often be accomplished by the addition or removal of soil. The ground should slope away from the house at a rate of one inch per foot for at least the first several feet.

Ponding water, sample

Task: Repair / Monitor

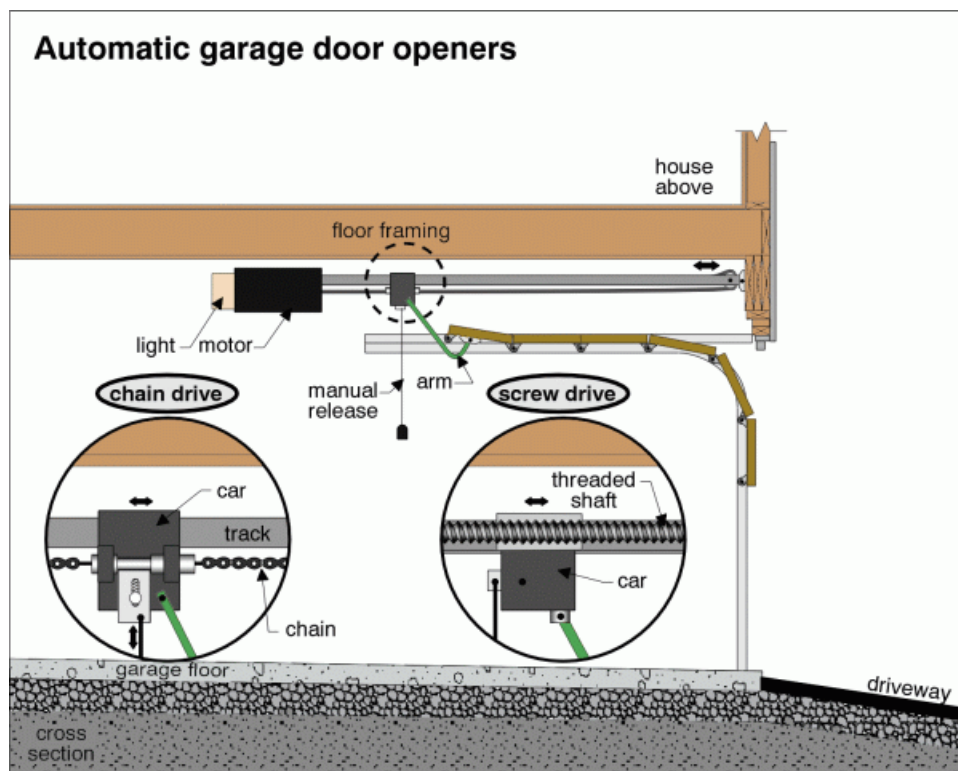
6. Condition: • Manual detachment device (safety cord/release handle) missing

Task: Repair / Install

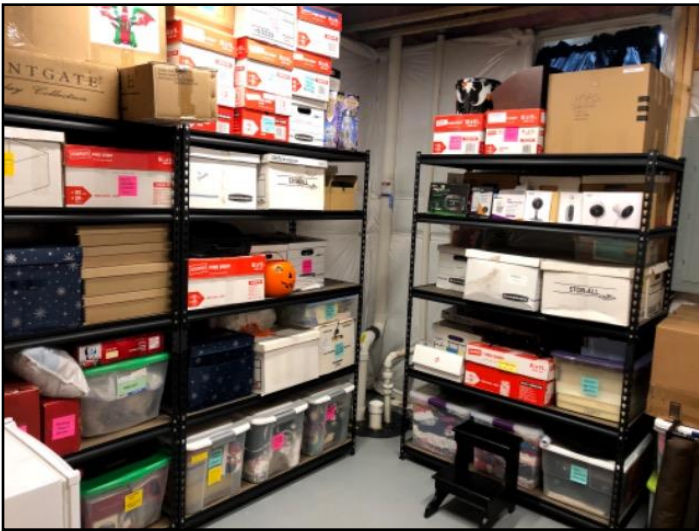
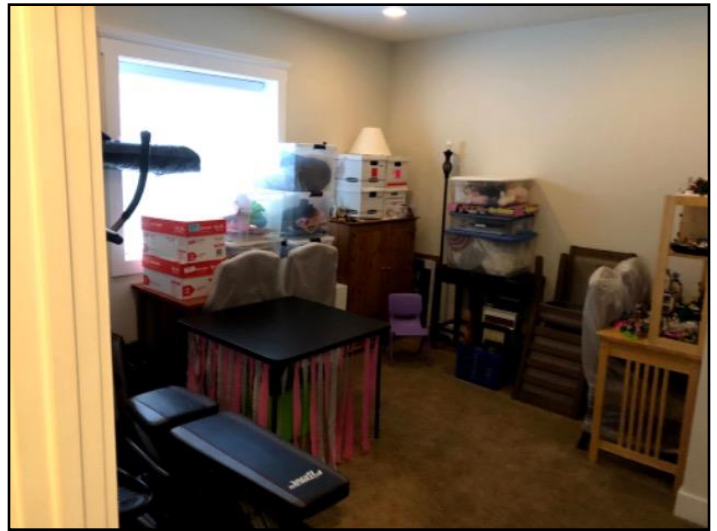
Inspection limited/prevented by: • The stored items in the basement currently obstruct access to certain sections of the unfinished areas. Inspection of these areas is recommended after the storage is cleared.

Storage sample photo

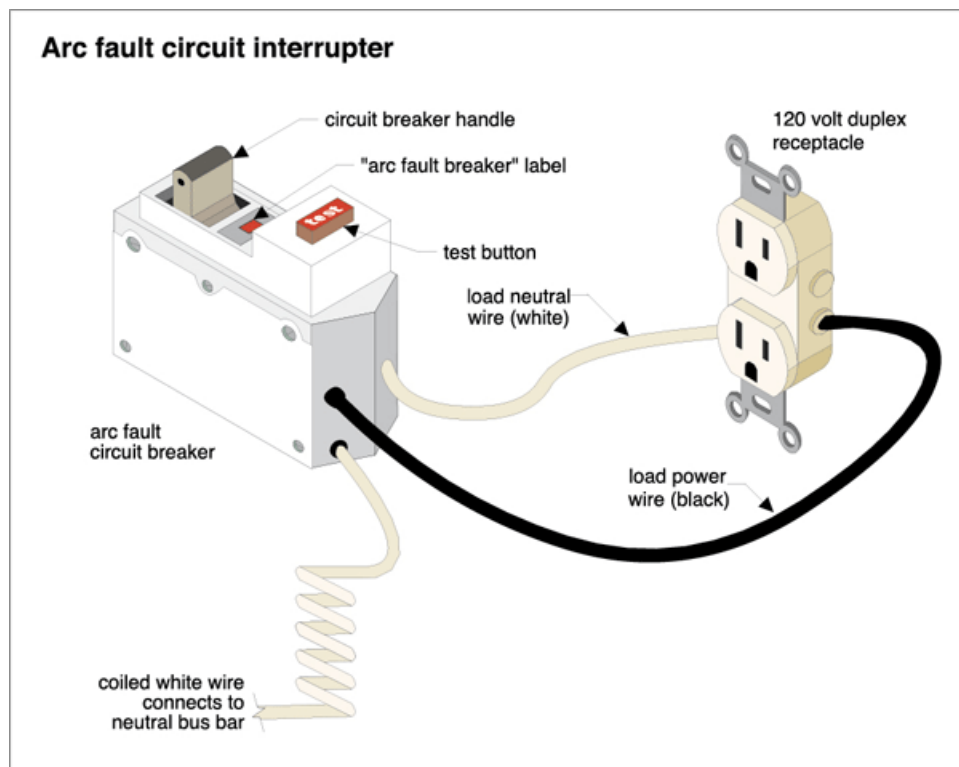
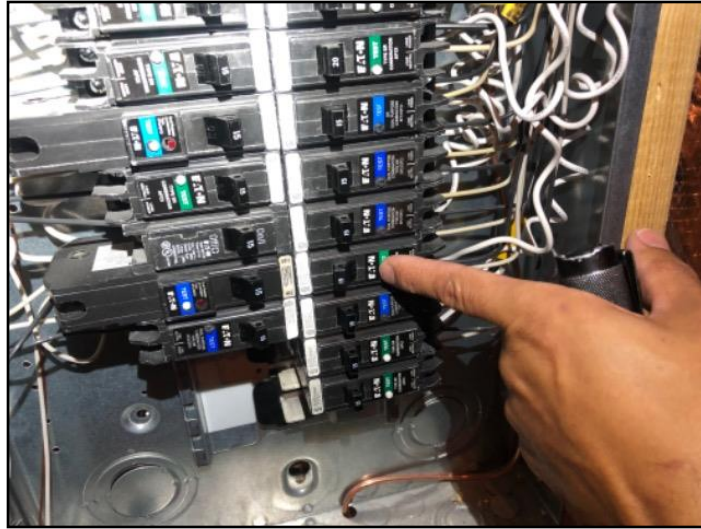
9. Condition: • [Arc Fault Circuit Interrupter \(AFCI\) test faulty](#)

The breaker should be replaced.

(AFCI) test faulty, sample

Task: Replace

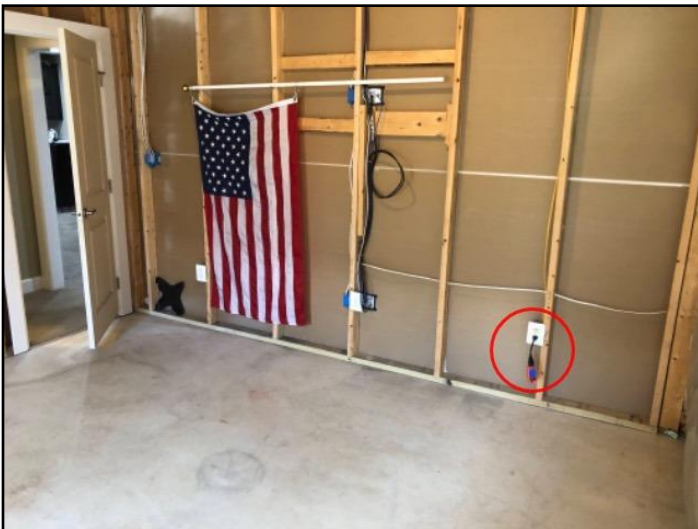
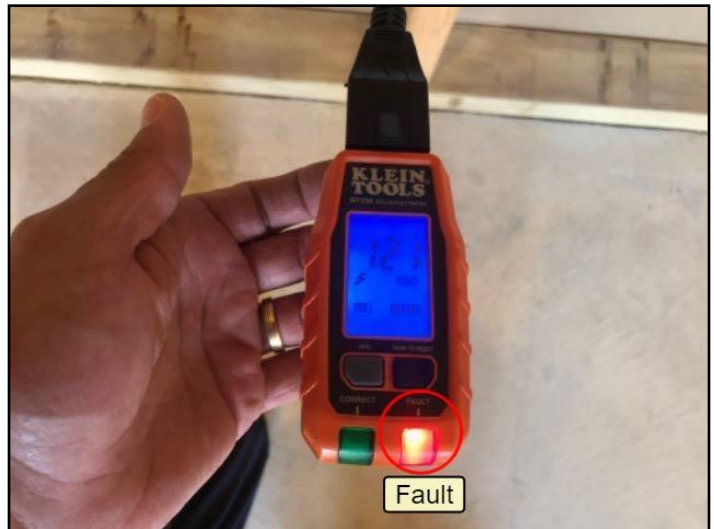
11. Condition: • Electrical receptacles/outlets in the basement were improperly wired and should be evaluated and corrected by a qualified electrician as needed.

Improperly wired outlet, Location sample

Improperly wired outlet, sample photo

Task: Repair or replace

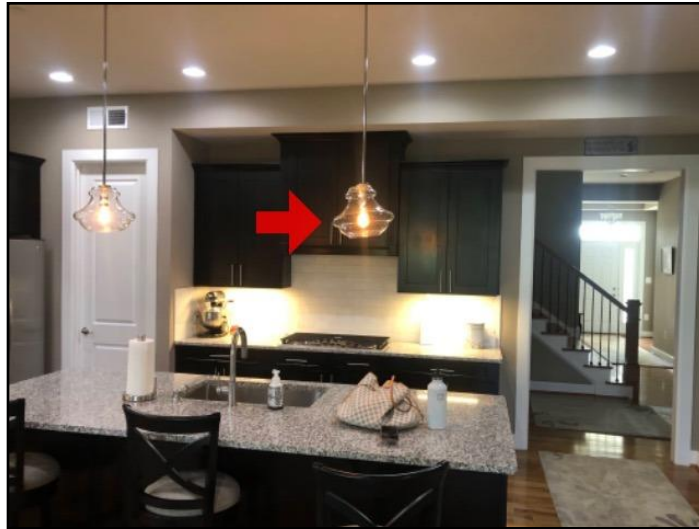
12. Condition: • A lighting fixture is slightly cockeyed and could be adjusted if desired so that it is square in and lined up.

Lighting fixture is slightly cockeyed

Task: Improve/ Repair as desired

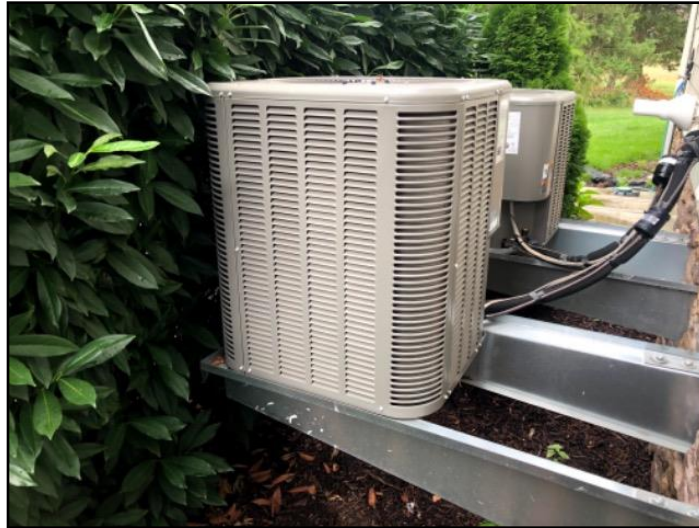
The air-conditioner compressor unit was excessively noisy during operation. This can indicate that the system is low on refrigerant and should be serviced by a qualified HVAC technician.

Excess noise /vibration - sample

Task: Further evaluation / Service

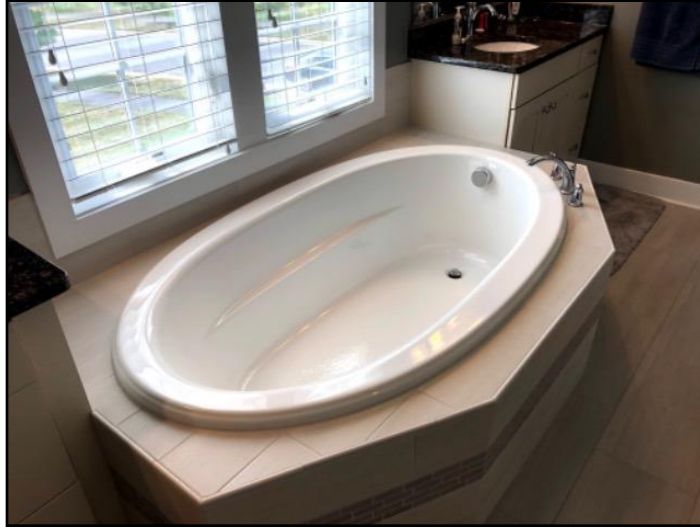
Condition: • Excessive flex and creaking in the bathtub floor indicate potential support issues. There was no evidence of any cracking or failure but monitor closely to prevent future cracks or leaks. It is impossible to predict how long the tub will continue to function properly.

Excessive flex and creaking, sample

Task: Further Evaluation / Repair as Needed

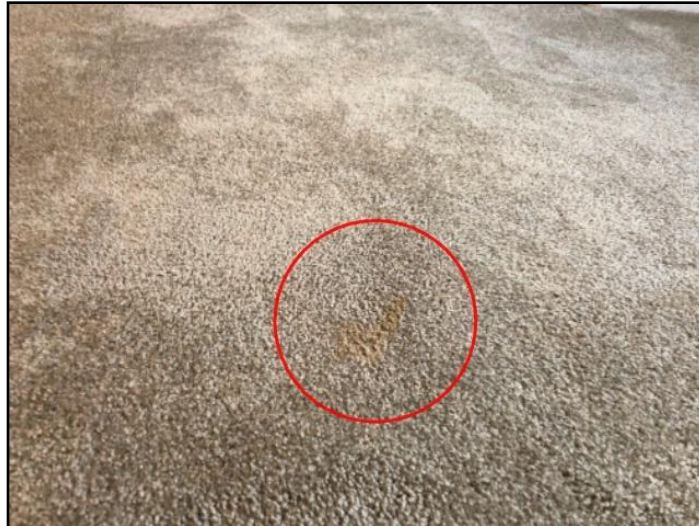
Stained carpet, sample

Task: Improve;

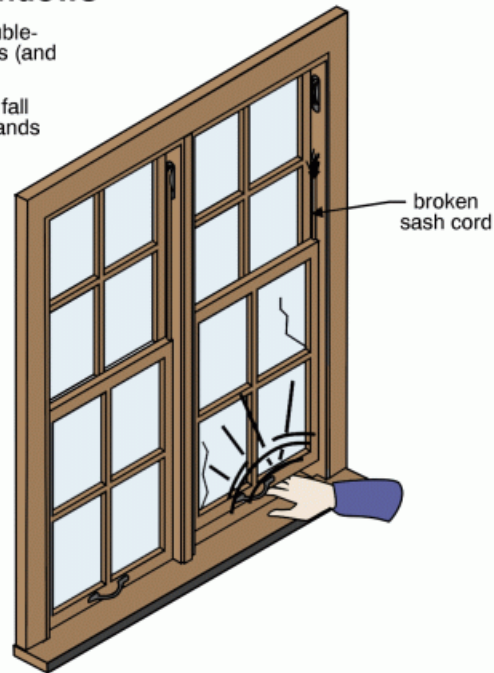
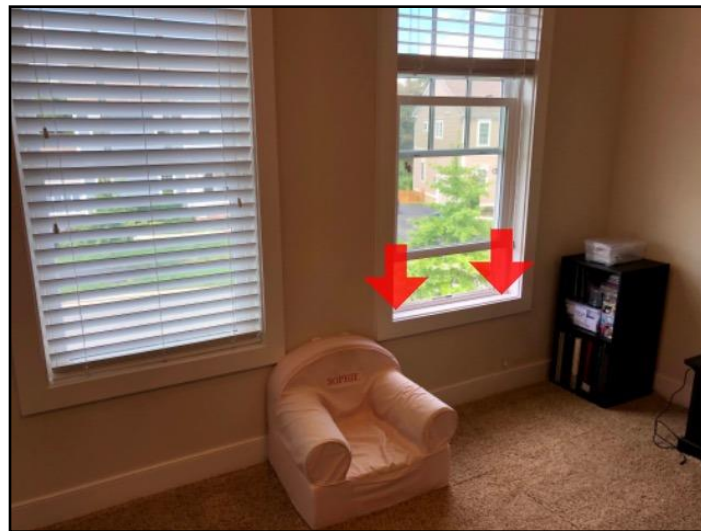
Condition: • [The window won't stay open. The mechanism that holds the window up when opened may be defective. If the window falls, it can cause injury if your hands are below. The window and its glass can also be damaged. I recommend repairing or replacing the hardware, so that the window shuts, opens, locks and seals properly.](#)

The window won't stay open

Task: Repair or Replace

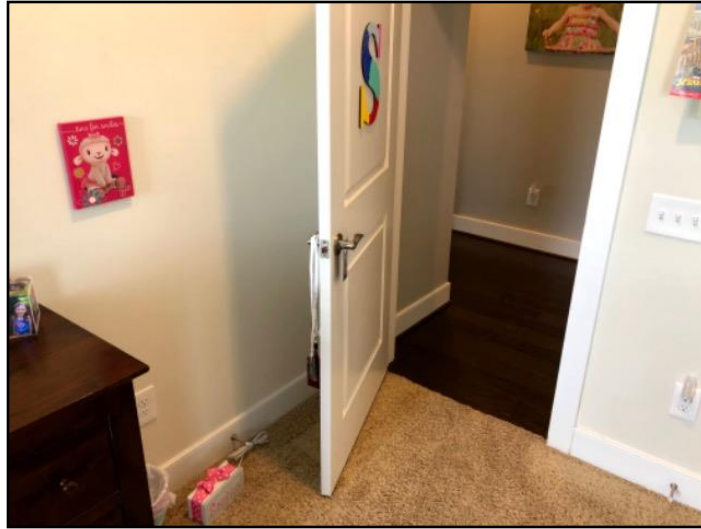
Does not latch properly

Task: Improve / Repair

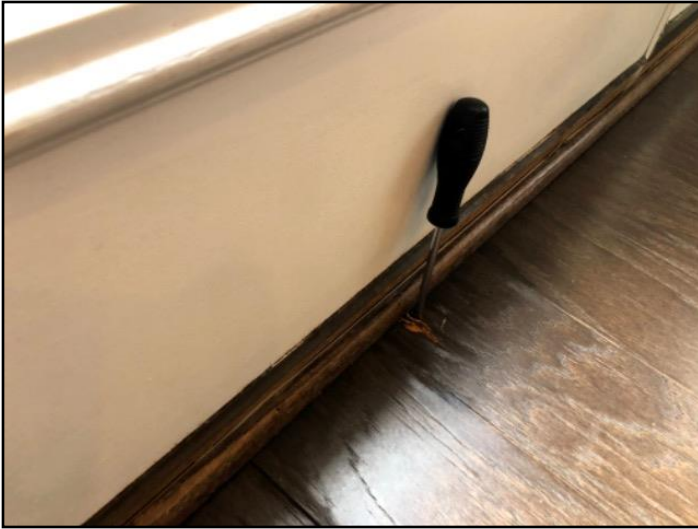
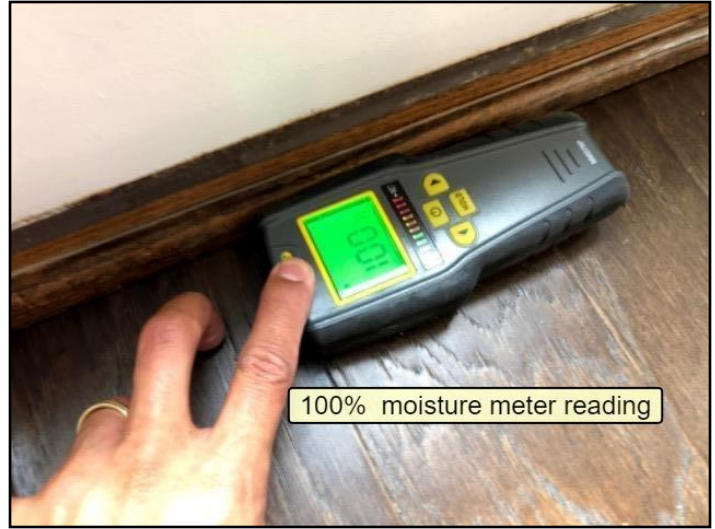
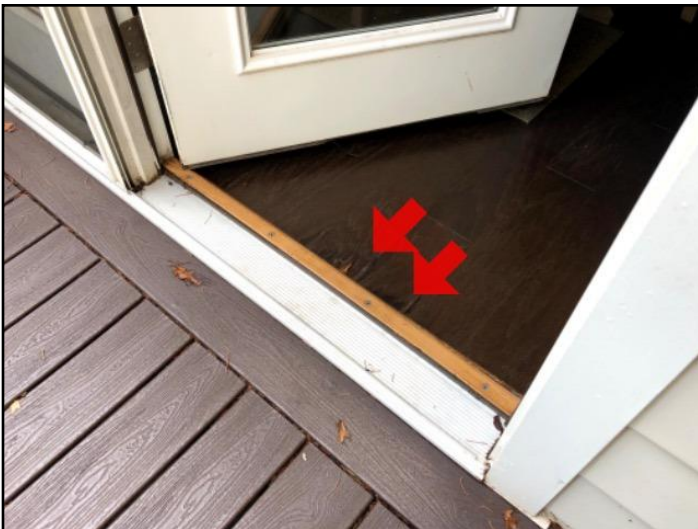
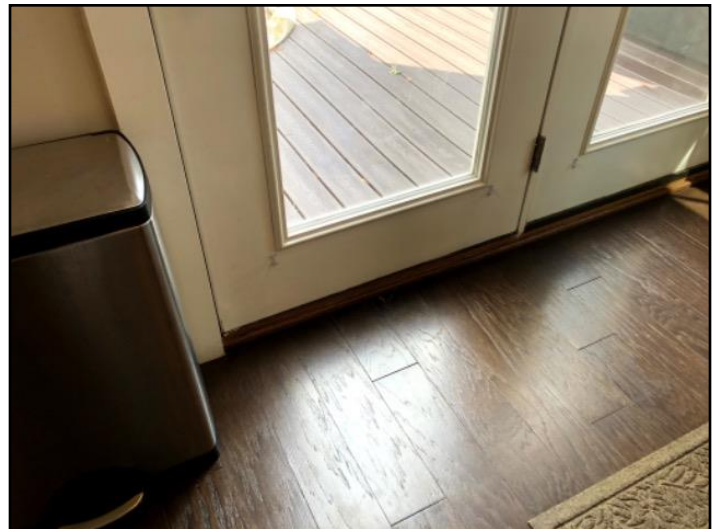
Condition: • Evidence of leakage was observed at the threshold and/or trim of the exterior door. Efforts should be made to make the door watertight. It was noted that wood rot was around the base of the door (bottom left). When checking the moisture level with the moisture meter, it tested wet, so it is very likely that there is damage to the wood below it and there may also be mold.

Wood rot was noted, sample photo

Tested wet (100%) checked with moisture meter

Evidence of leakage - Locatioin sample photo

Be advised that repair may require the replacement of the door. The door and/or frame should be repaired or replaced as needed.

Task: Further evaluation / Repair or replace

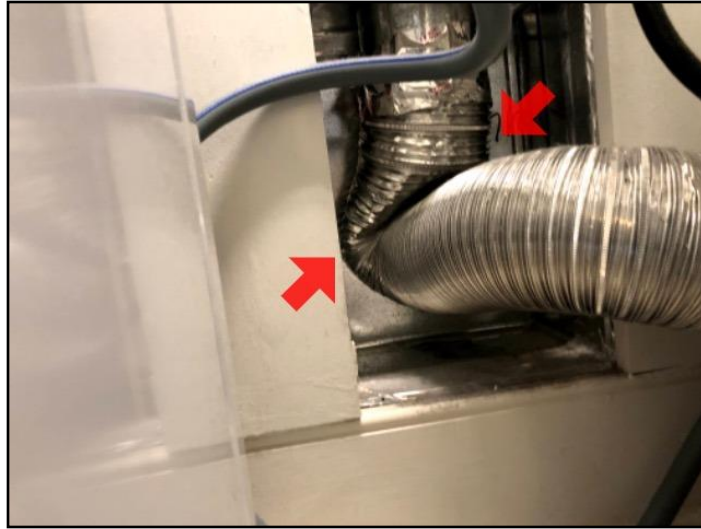
Condition: • The dryer exhaust duct was kinked and/or crushed where it exited the back of the dryer. This condition creates a restriction in dryer exhaust that can result in lint accumulation or duct blockage. A restricted exhaust can also cause dryer overheating, which can shorten the expected long-term service life of the dryer and even increase the risk of fire.

The clothes dryer exhaust vent is crushed

Task: Repair or Replace

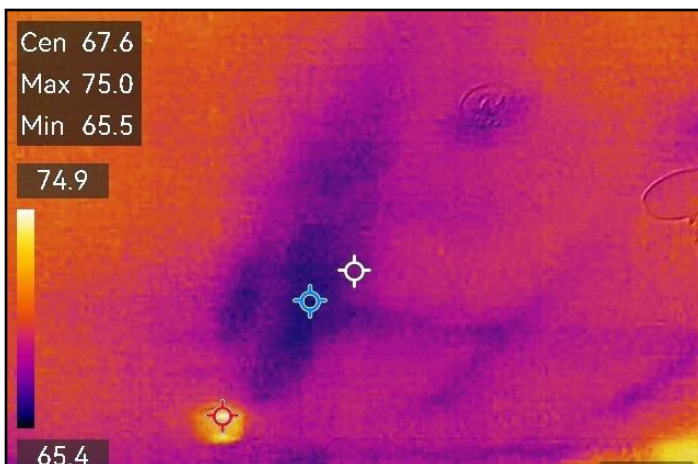
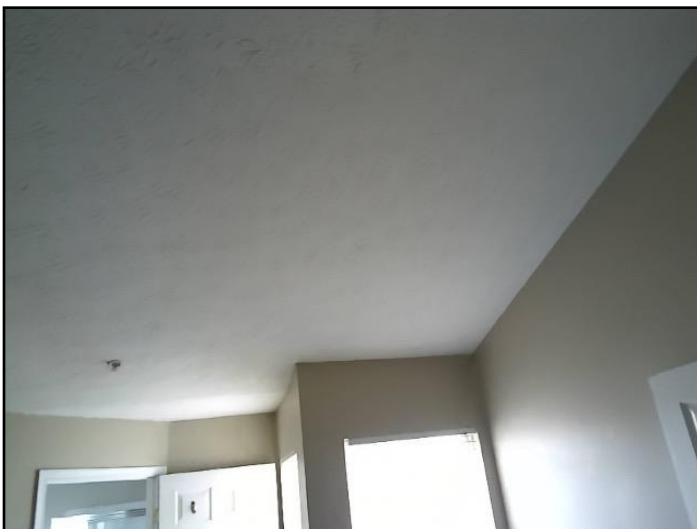
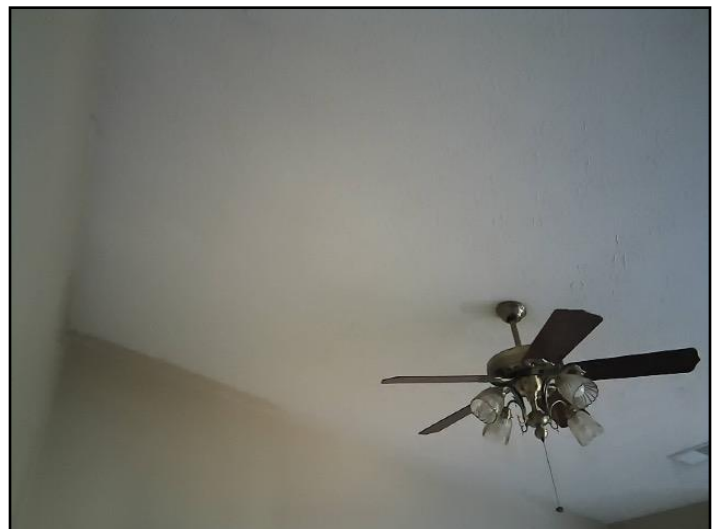
Condition: • Evidence of prior moisture issues was noted through interior finish stains and/or repairs in the second-floor primary bedroom (see photos). While no active leaks were detected during the inspection with a moisture meter, thermal imaging revealed temperature variations in the same area, suggesting potential moisture intrusion within the built-up roof system. Thermal imaging, which visualizes temperature differences, can sometimes indicate hidden moisture issues. To fully assess this, I recommend:

Thermal image revealed/temperature difference

Evidence of prior moisture, Location sample

- Inquiring the owner about any previous leaks or water-related concerns and whether they were addressed.
- If the owner is unaware of any previous repairs or if the underlying source of the moisture remains unaddressed, further evaluation should be undertaken by a qualified contractor before the Inspection Objection Deadline to further evaluate this condition and determine any necessary repairs.

Task: Inquire / Further evaluation, repair as needed

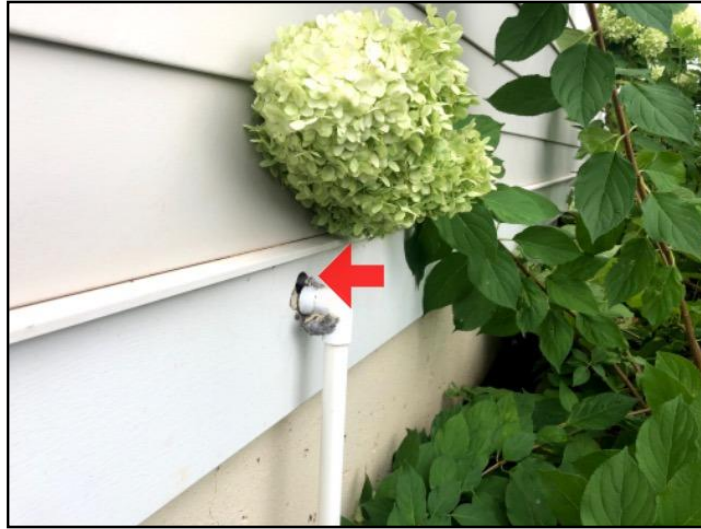
Exterior - Annual Maintenance: • Exterior wall penetrations had gaps that should be sealed with an appropriate sealant to prevent moisture and insect entry.

Penetrations should be sealed, sample
