PREPARED FOR:
JOHN DOE (SAMPLE REPORT)

INSPECTION DATE:
Wednesday, May 15, 2019

Your Inspection Report

Report No. 1013, v.2

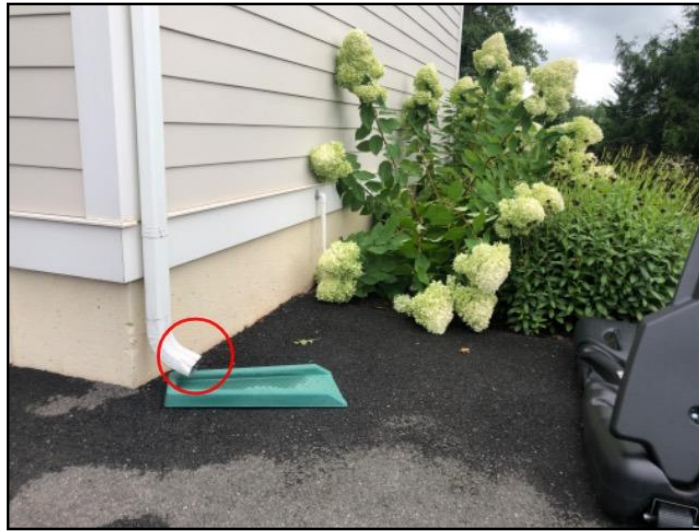
Sample

3. Condition: • Downspout connection: I recommend improving the connection between the downspout and the extension. Make sure all downspouts are connected and routed to discharge water away from the home foundation.

Task: Repair

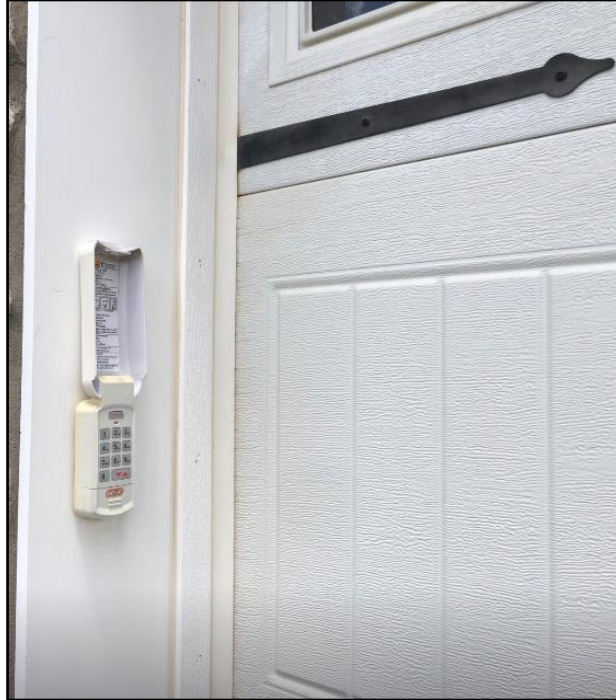
Keypad access code - Inquire

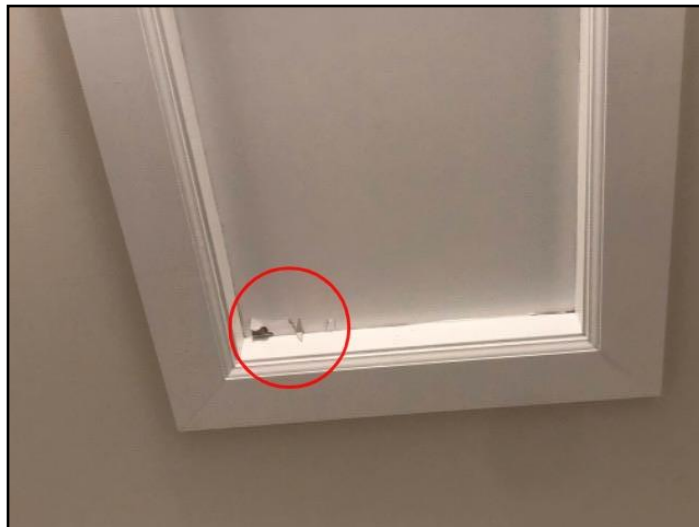
Sample

Location: Attic hatch (See photo)

Task: For Information / Improve as desired

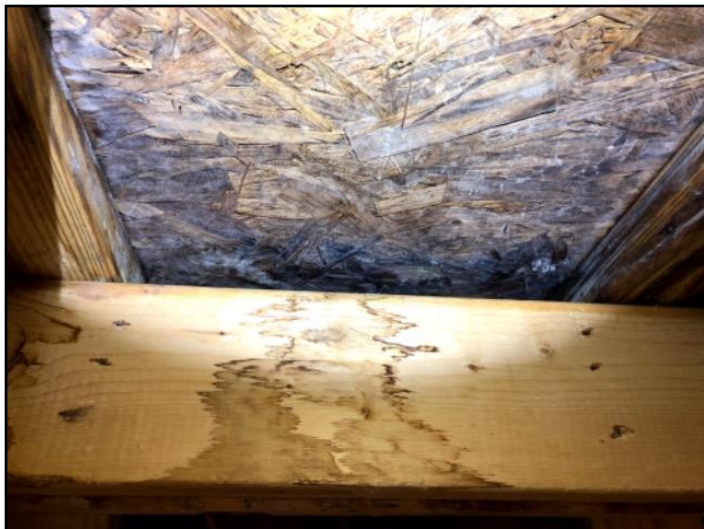
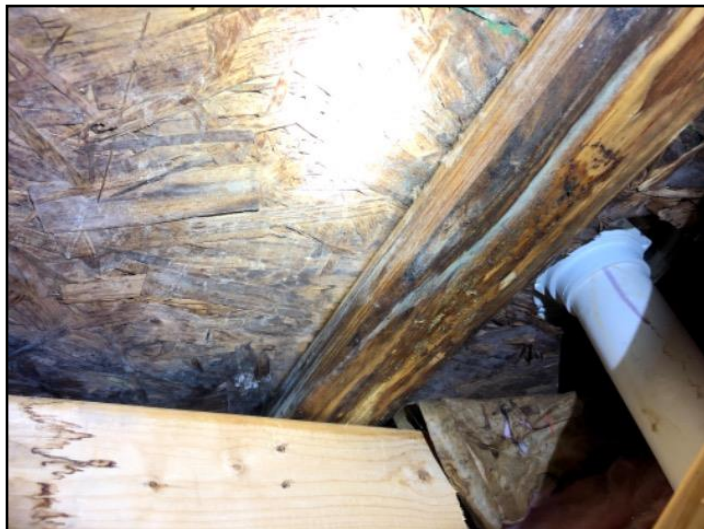
Primary Bathroom OSB Subfloor, sample

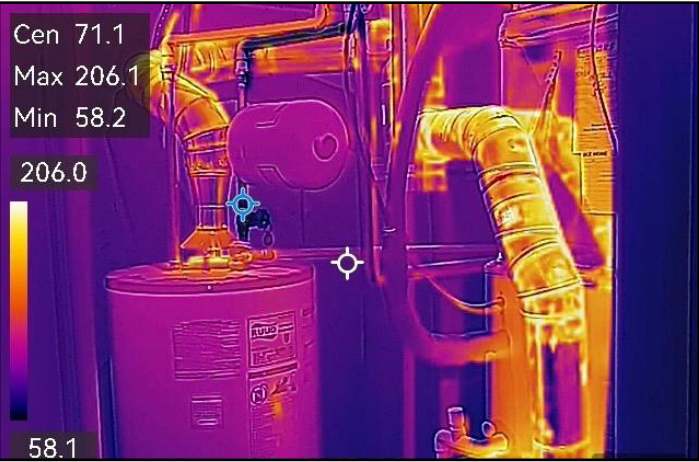
General Infrared/Thermal Image, sample

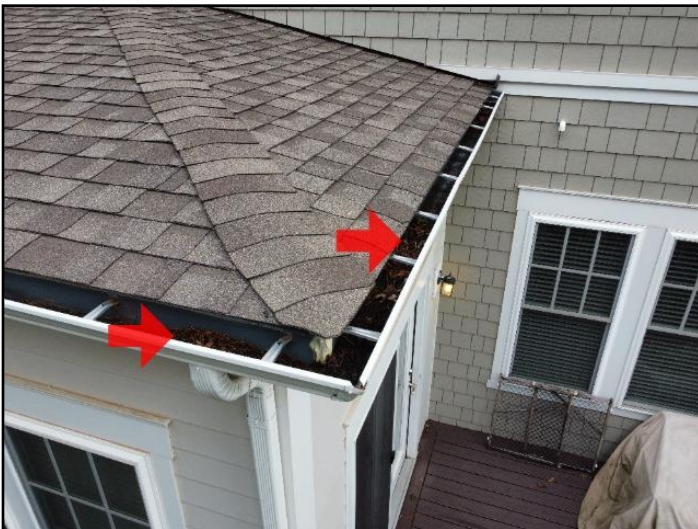
Time to clean the gutters!

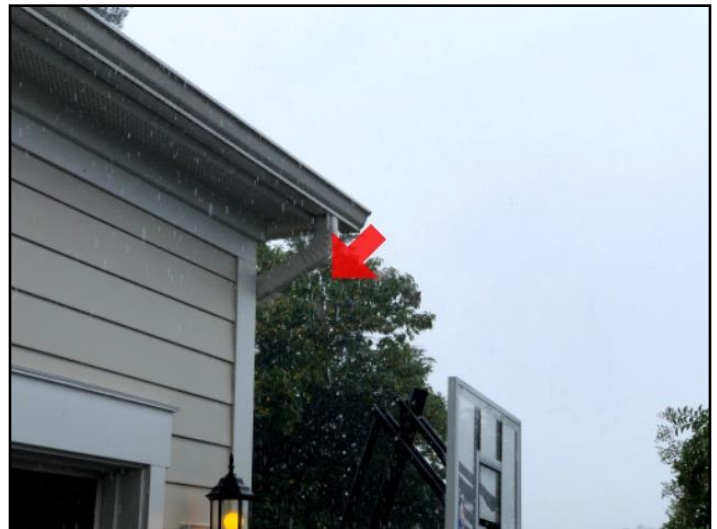
Time to clean the gutters!

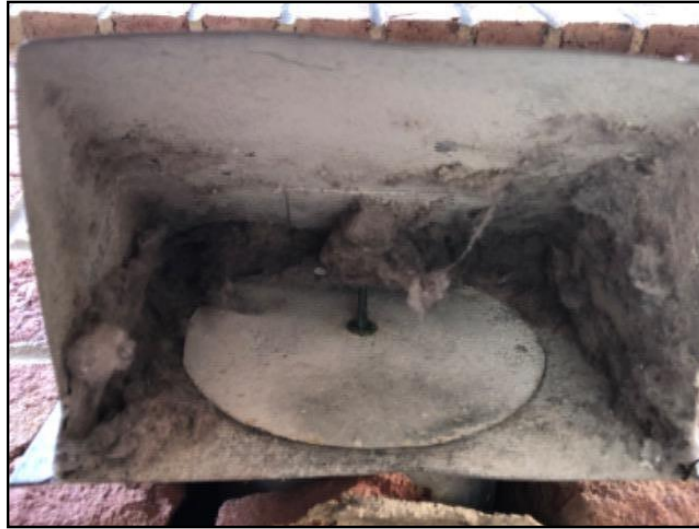
Time to clean the dryer vent!

- We recommend that vents for clothes dryers discharge outside the home. The vent material should be smooth walled (not corrugated) metal, and the run should be as short and straight as practical. This reduces energy consumption and cost, as well as drying time for clothes. It also minimizes the risk of a lint fire inside the vent.
- Dryer ducts should be inspected annually and cleaned as necessary to help reduce the risk of a fire, improve energy efficiency and reduce drying times.
